**PHASE I INSPECTION REPORT
NATIONAL DAM SAFETY PROGRAM**

**JACKSON LAKE DAM
WHITE SULPHUR SPRINGS, MONTANA
MEAGHER COUNTY
MT 53**

**HKM ASSOCIATES
BILLINGS, MONTANA**

MARCH 1981

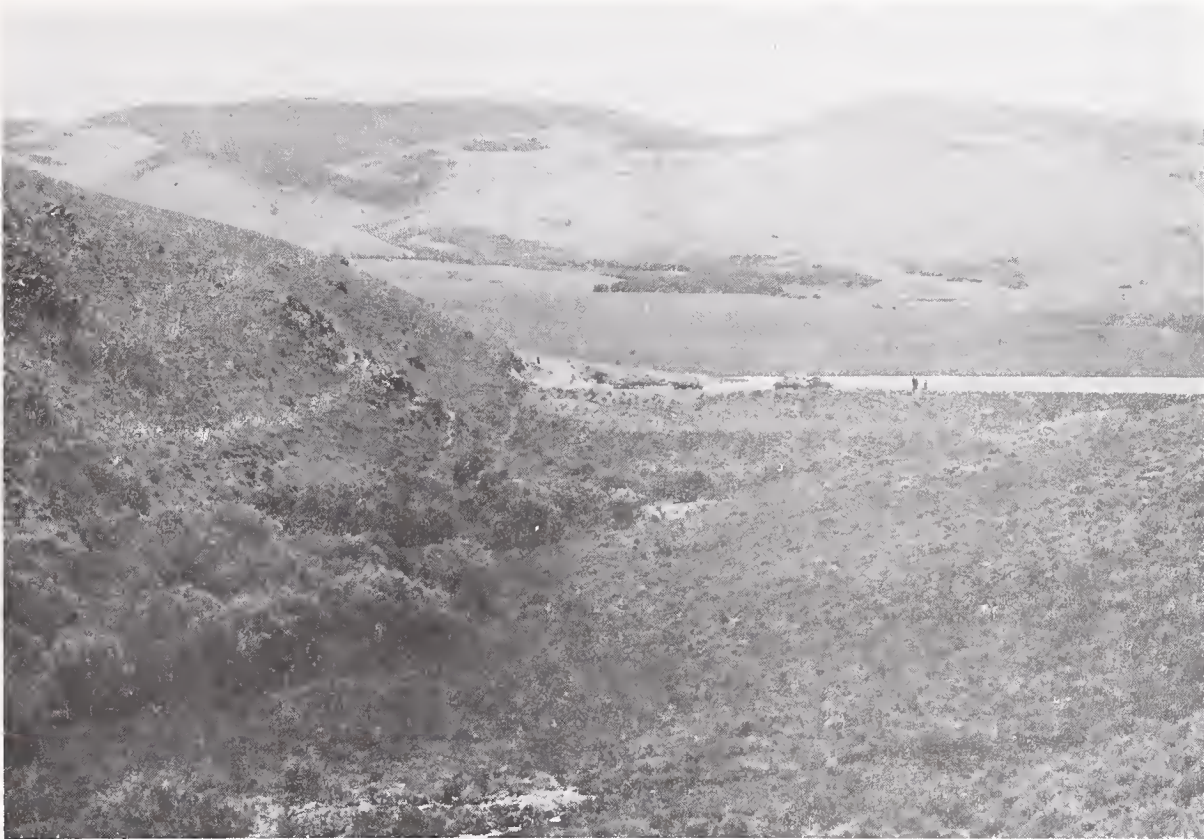
Photo No. 1 - Damsite.

There is no record of any foundation investigation performed at the damsite either before or since construction. No soils information is known except that which was observed at the surface during the field inspection. The dam appears to be founded on shallow alluvial deposits of clay, sand, and gravel overlying weathered shale. The abutments are highly fractured deposits of shale and argillite bedrock (Photo No. 1).

Shown is the downstream face of the dam embankment with the upstream watershed in the background.

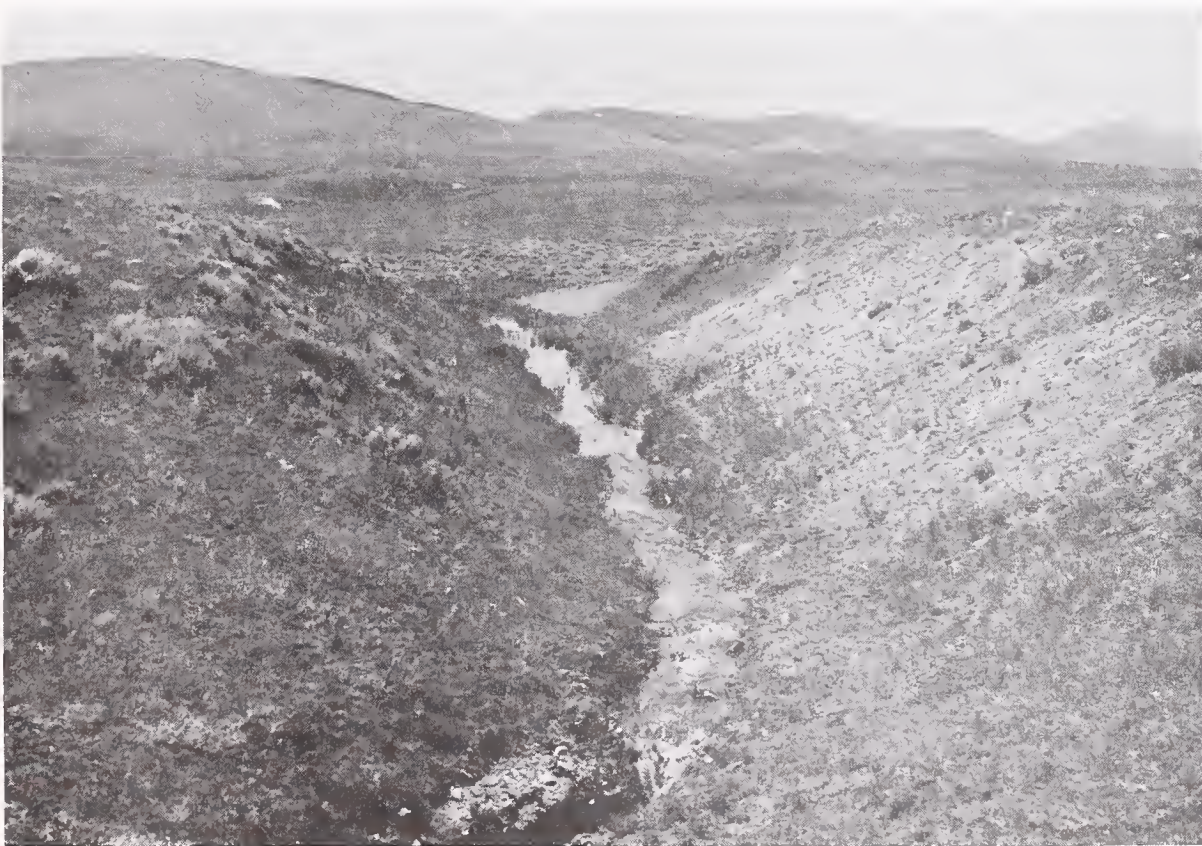
Photo No. 2 - Spillway.

The uncontrolled earth spillway is shown looking upstream from the control towards the reservoir.

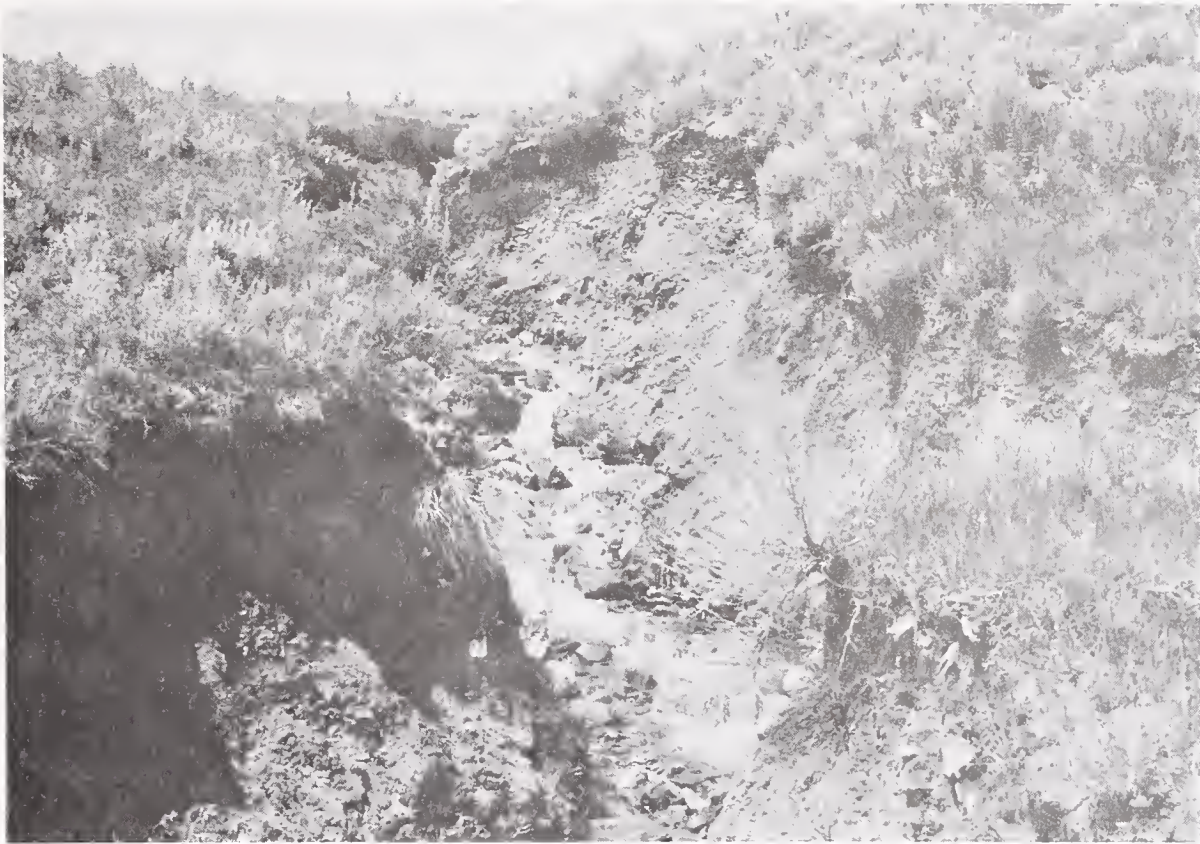
Photo No. 3 - Spillway.

Erosion of soil and soft shale materials in the spillway return channel was noted during the field inspection. This can be expected to continue unless some protection is provided. The spillway approach channel is composed of highly erodible materials.

create a safety concern for the dam (Photo 3 of Exhibit B). In general, the spillway is in relatively good condition and should not pose a serious threat to the dam embankment.

The spillway channel downstream of the control is steep and deeply cut.

- (3) Perform the following repairs on the spillway: enlarge the channel cross section from approximately HKM Survey Station 1+60 to the vertical drop, or Station 3+60, and revegetate the side slopes along the spillway channel for stabilization.

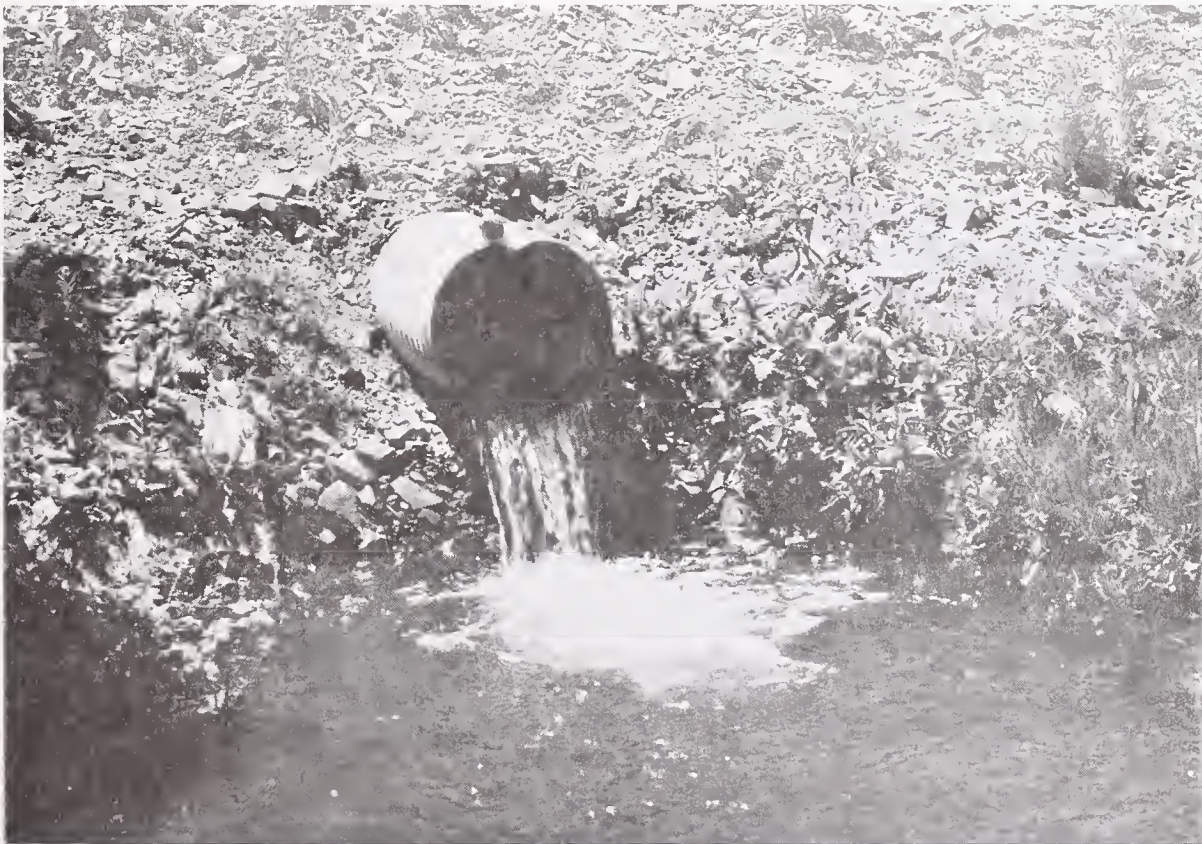
Photo No. 4 - Outlet Works.

The outlet pipe is a 15-inch corrugated metal pipe.

- (2) Perform the following repairs on the outlet works facility: provide better access to the riser which houses the gate controls; repair the gate operator, and install a cover for the riser to eliminate the possibility of unauthorized operation and to eliminate rock accumulations in the base of the riser; repair the gate seat; inspect the total length of the outlet works, including the intake area, and perform the necessary repairs; investigate the source of seepage below the pipe at the outlet (see Section 3.1.3), and identify potential adverse effects; and place additional rock riprap at the outlet to minimize downcutting and lateral scour, particularly for protection during peak releases.

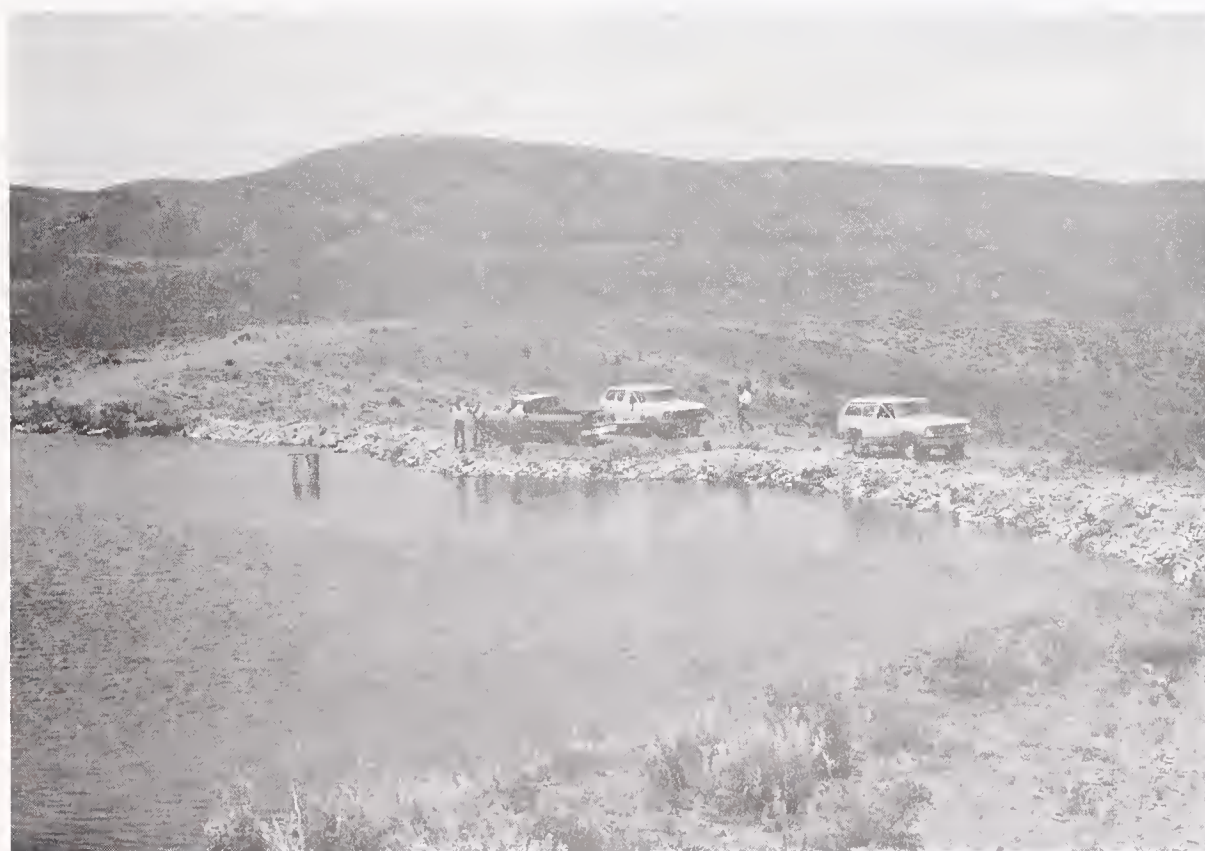
Jackson Lake Dam is an earth fill structure which was originally constructed in 1936 and remodeled three times with the latest work in 1978. A description of this remodeling is presented in Section 1.2.5. The dam has an estimated structural height above the deepest point on the foundation surface of 32 feet and a total crest length of 391 feet. The dam crest width varies from 20 to 30 feet (Photo No. 6). Construction drawings of the embankment are not available.

Photo No. 6 - Shown is the upstream face of the dam embankment and the 36-inch corrugated metal riser pipe.

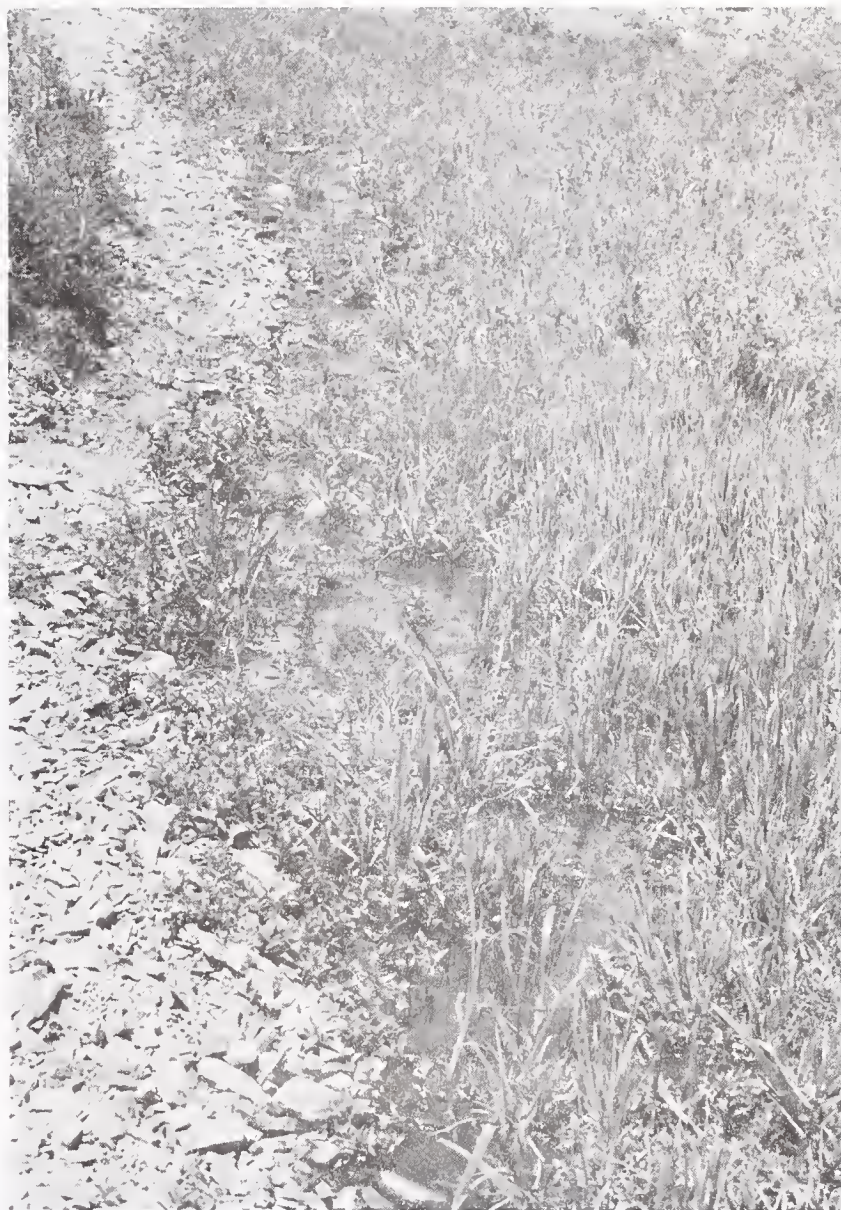
Some seepage was observed at the toe of the embankment along the valley floor, and in the downstream valley. No seepage was evident on the downstream face of the dam. Specific details relative to the phreatic surface through the embankment are unknown due to a limited informational base and the fact that field measurements could not be made. It is concluded, however, that the existing seepage does not pose any immediate structural stability problems.

Photo No. 7 - Dam Embankment.
Seepage is emerging along the
downstream toe of the dam.

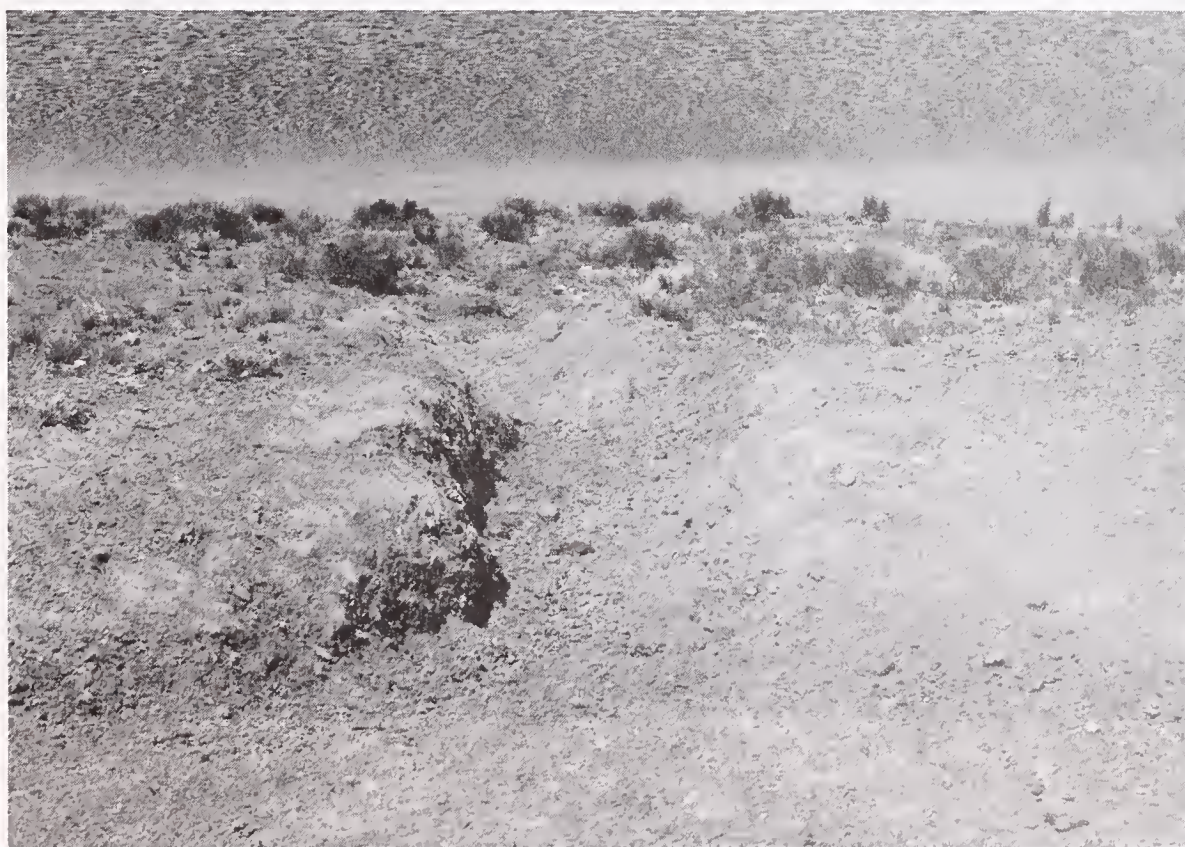
Photo No. 8 - Reservoir.
Erosion channel along the south (right) side of the
reservoir has been cut due to localized runoff.

- (5) Repair the erosion gully which has developed immediately upstream of the right abutment area, and modify the localized runoff system to eliminate future erosion in this area.

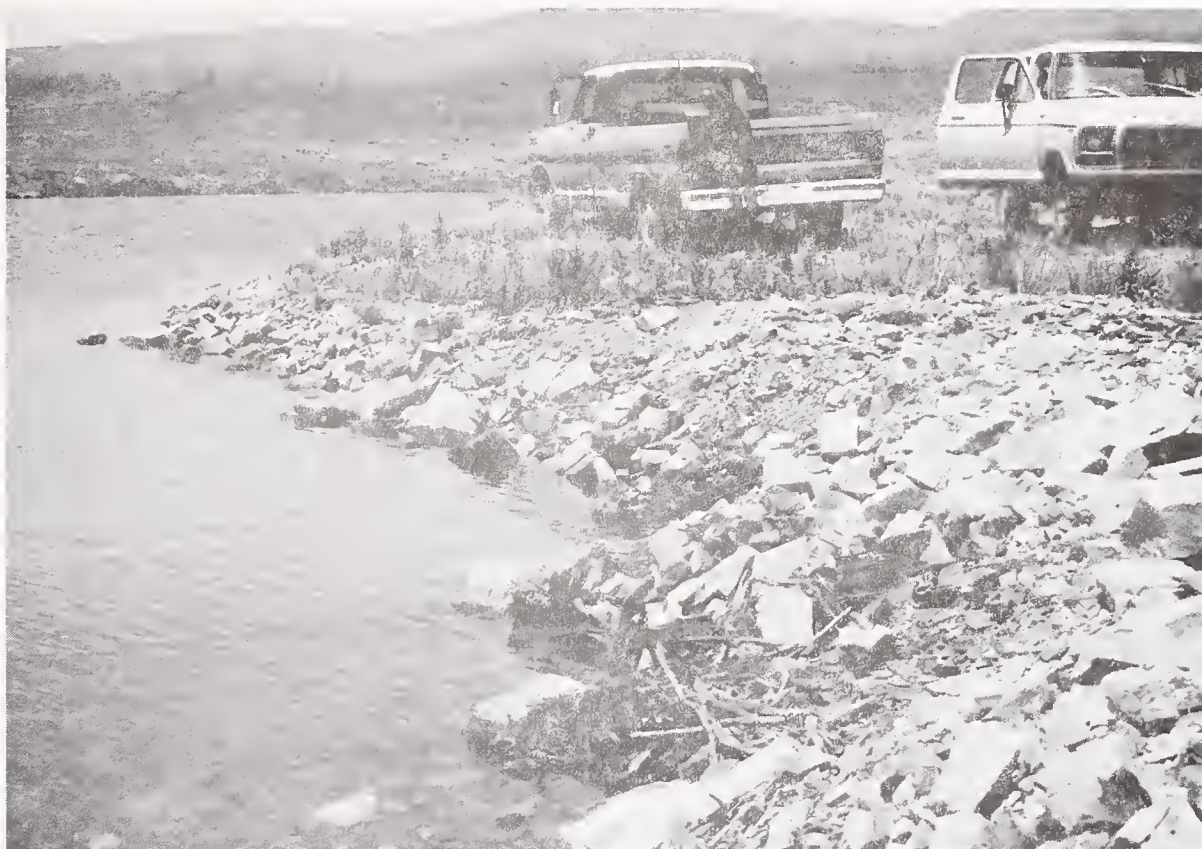
Photo No. 9 - Dam Embankment.

The riprap along the upstream face of the dam is pictured.

- (4) Perform the following repairs on the embankment: replace/rearrange rock riprap on the upstream face where wave action has caused erosion or moved the rock riprap downslope, and remove the small bushes from the upstream face.

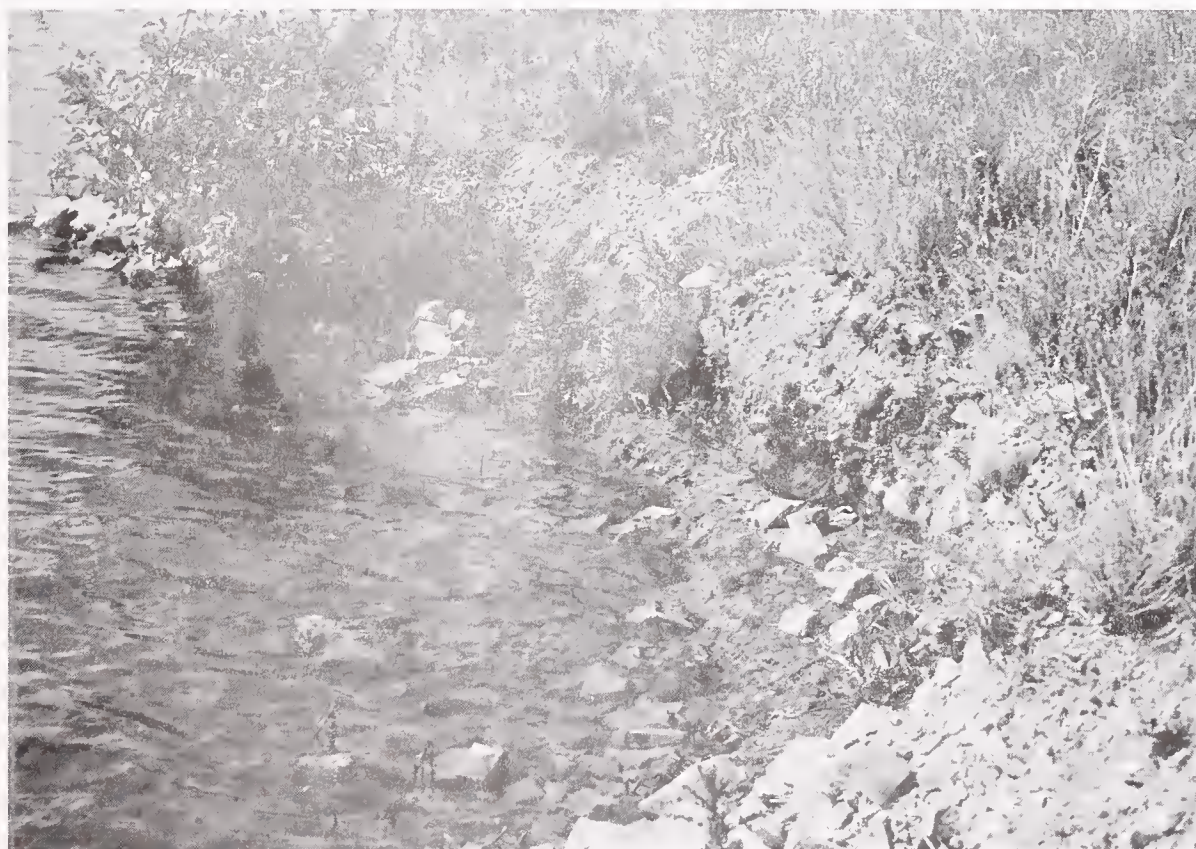
Photo No. 10 - Dam Embankment.

Because of the dam and reservoir orientation and consequent damaging wave action, periodic maintenance has been required on the upstream face of the dam. The last major repair was made in

Wave action has eroded the upstream dam embankment to near vertical cuts.

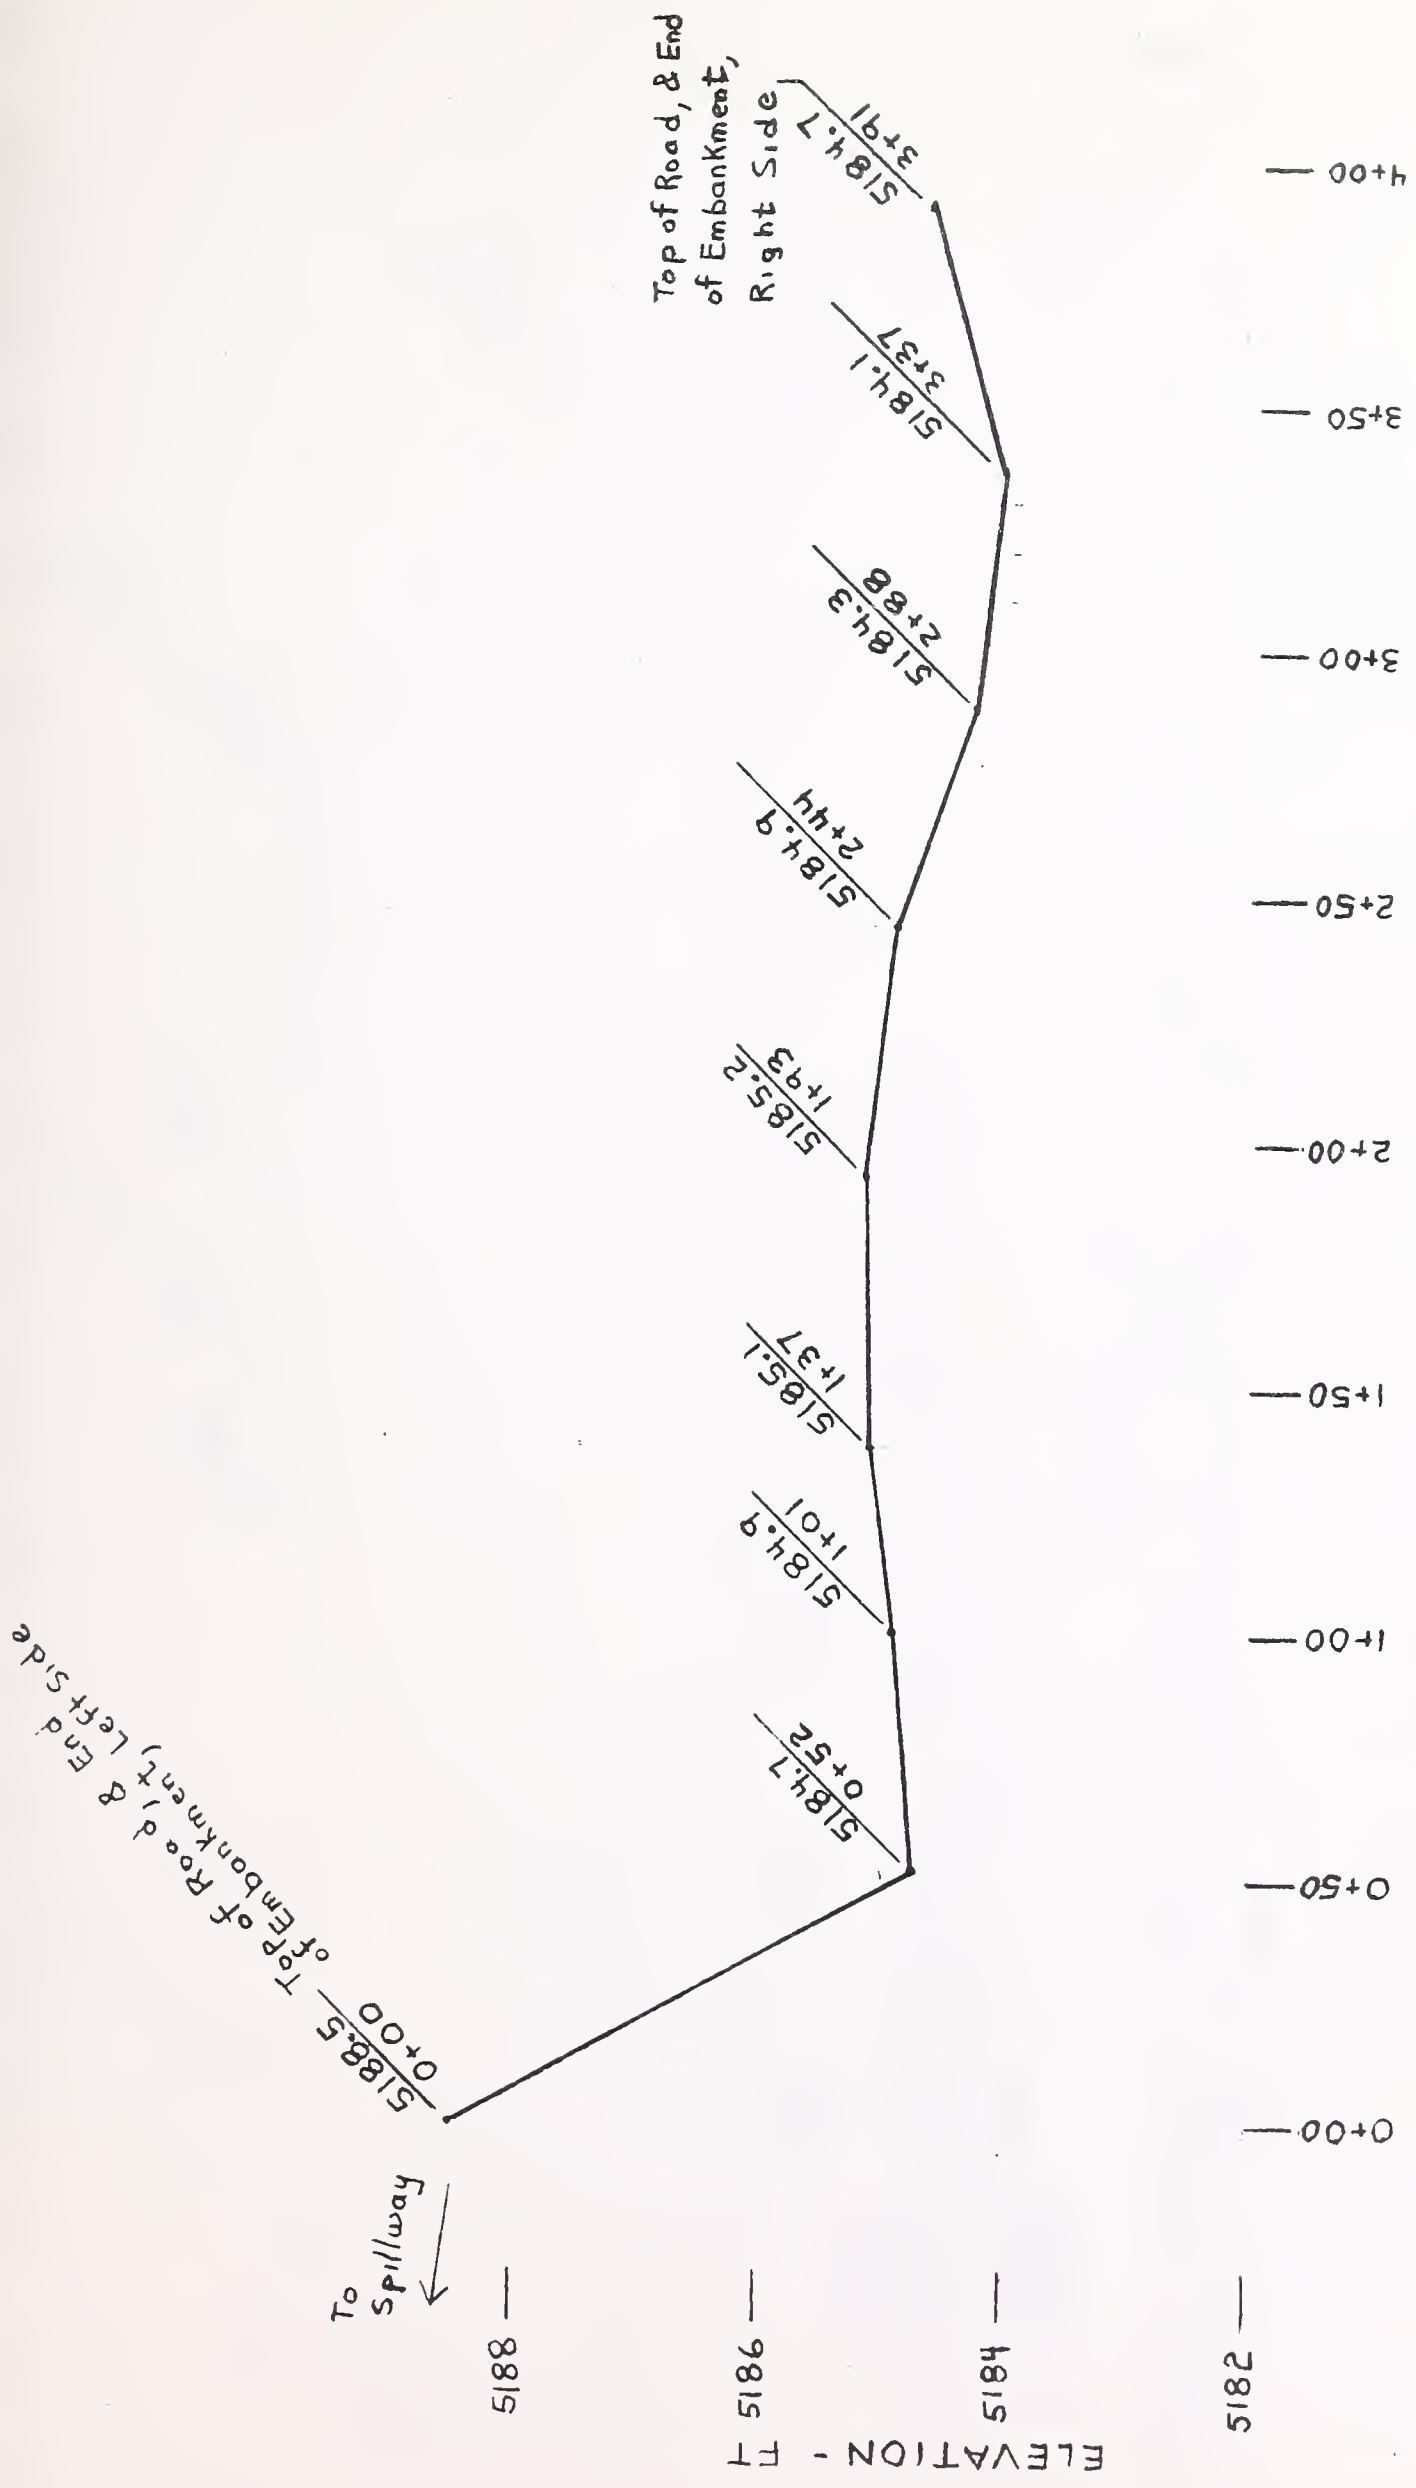
EXHIBIT C3 DAM CREST PROFILE JACKSON LAKE DAM

A dam crest profile was surveyed during the field investigation (Exhibit C3 of Appendix C). The survey shows that the maximum differential elevation along the dam crest centerline is about 1.1 feet. Some fill has been placed on the abutments at elevations as high as 3.4 feet above the low point on the crest. It appears the dam was designed without camber, or it has settled out. The amount of settlement which it has assumed cannot be determined. In summary, the settlement to date has not caused significant structural damage. Because the dam has aged nearly 12 years since the last crest raising, additional significant amounts of settlement are not anticipated.
